**Stoney Creek Bridge 5  
Replacement Project  
September, 2024**

Our new Bridge 5, something for which we've been waiting 33 months. The project was started on September 1st and completed on September 19th. It's a skookum structure, supported by two galvanized steel beams 18 metres long and .6 metres deep, made by Level Fabricators in Chilliwack. The deck, made of treated wood planks, is 1.9 m wide, while the handrails are 1.1 m high and 1.6 m apart.

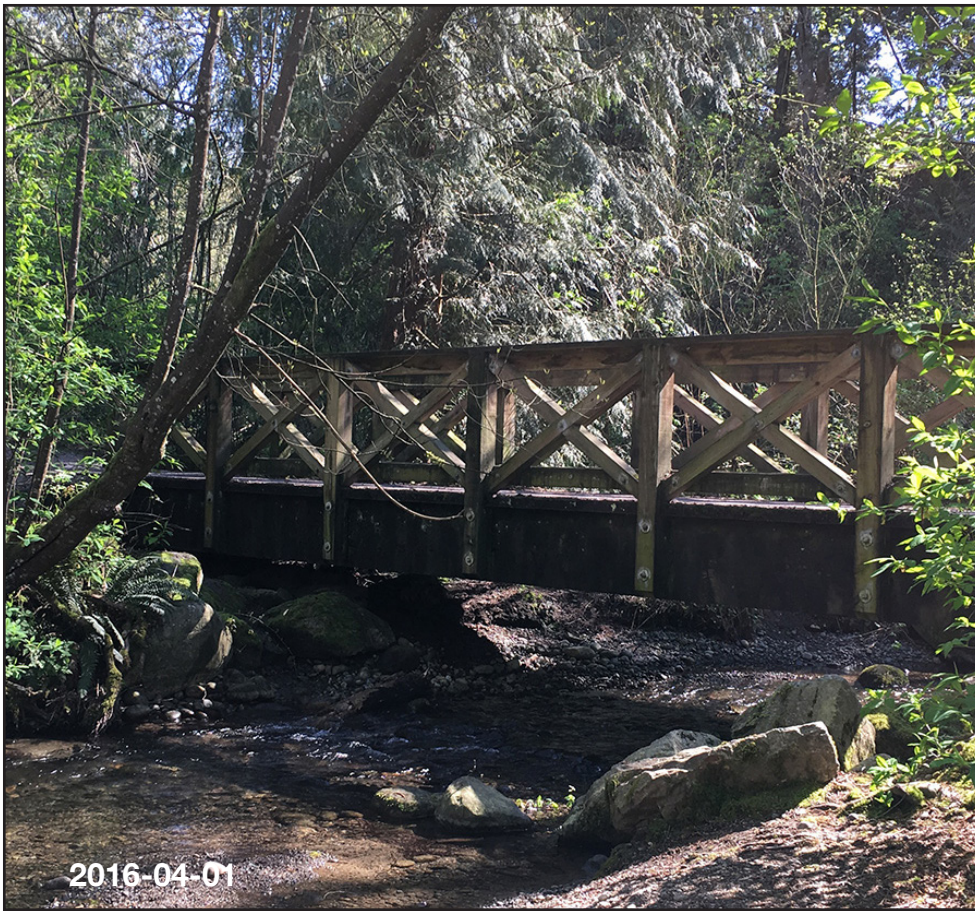
The older Bridge 5 (above, left) was destroyed during the Atmospheric River event in November, 2021. It was actually the second bridge at this location. It had replaced one of the original wood arch bridges similar to Bridge 4 (above, right) that had also been taken out by a high water event about 25 years ago.

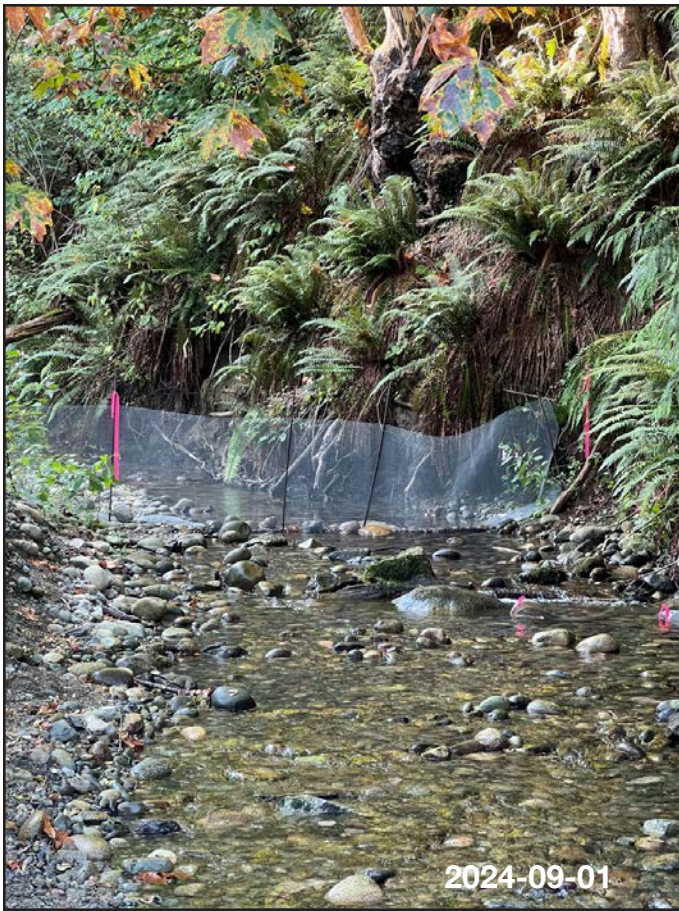
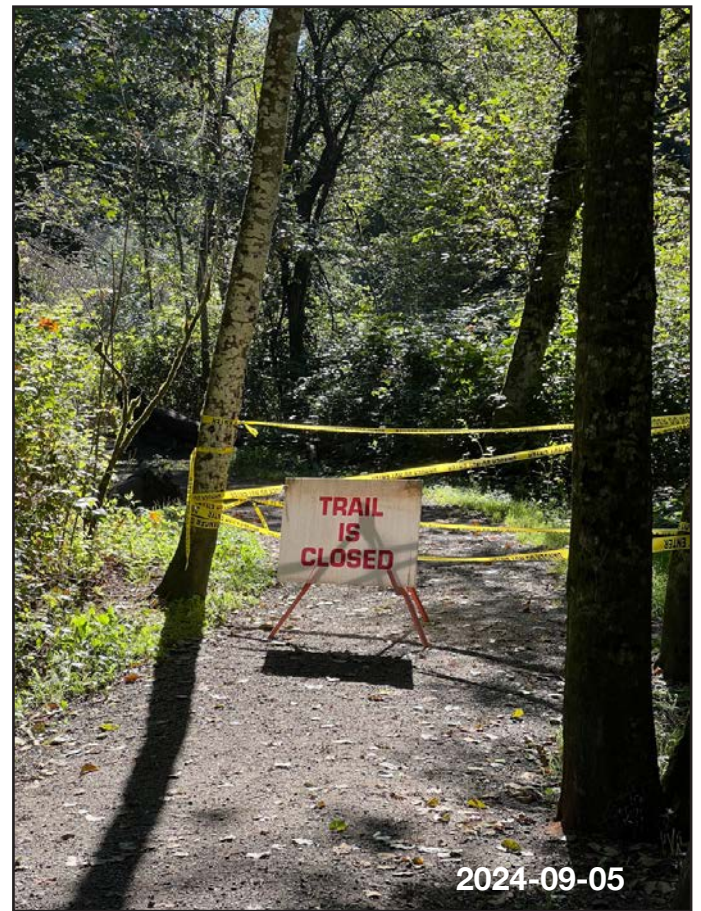
**Above:** the first signs that the project was underway. Measures were taken to keep critters (and people) out of the work area. **Below:** pumps and hoses were used to divert Creek water out of the work area. Happily, critters such as Coho, lampreys and crayfish were found and moved away from harm.

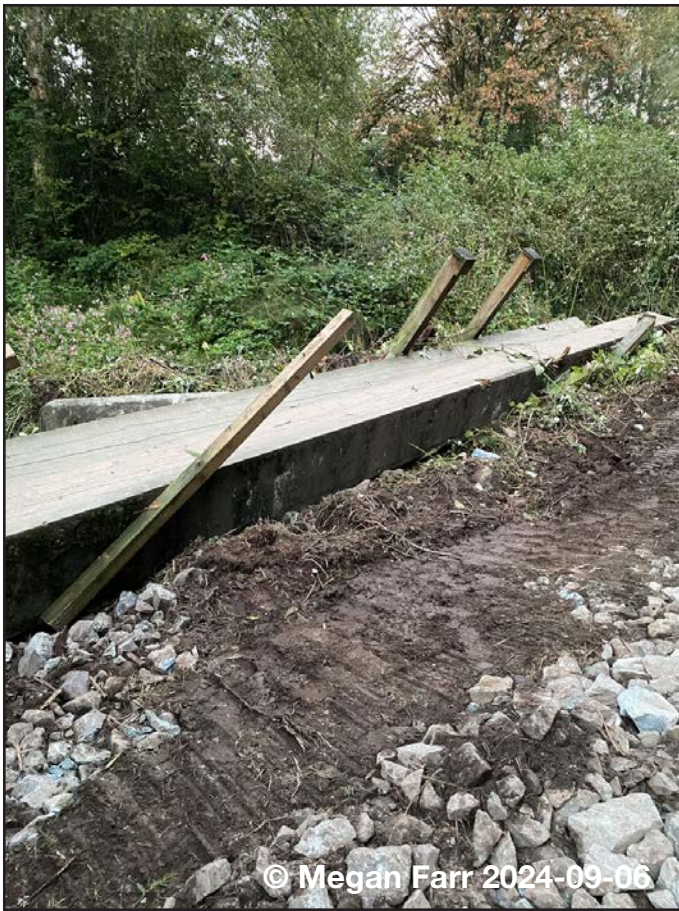
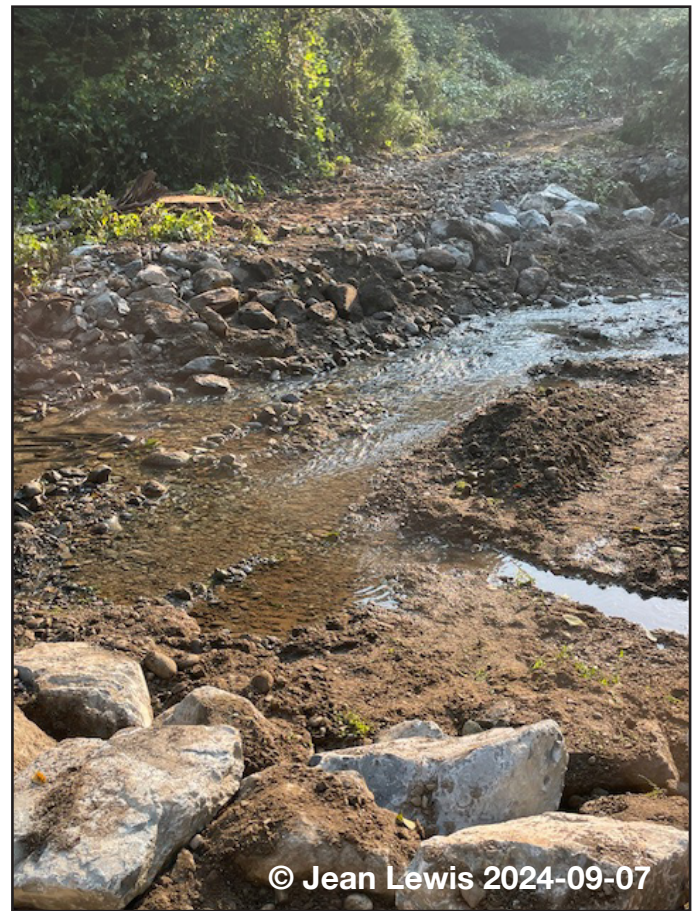
**Above:** next came the removal of two large wood beams, the remains of the old bridge. You can see the Creek water had not yet been diverted through those red hoses. **Below:** the first step in the new installation, the placing of concrete lock blocks to make the north abutment.

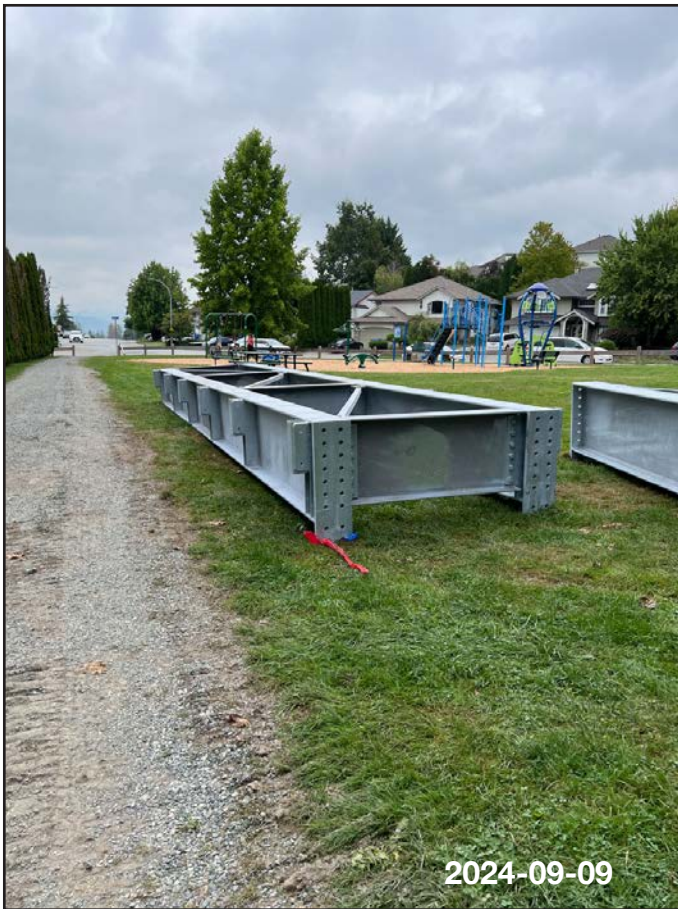
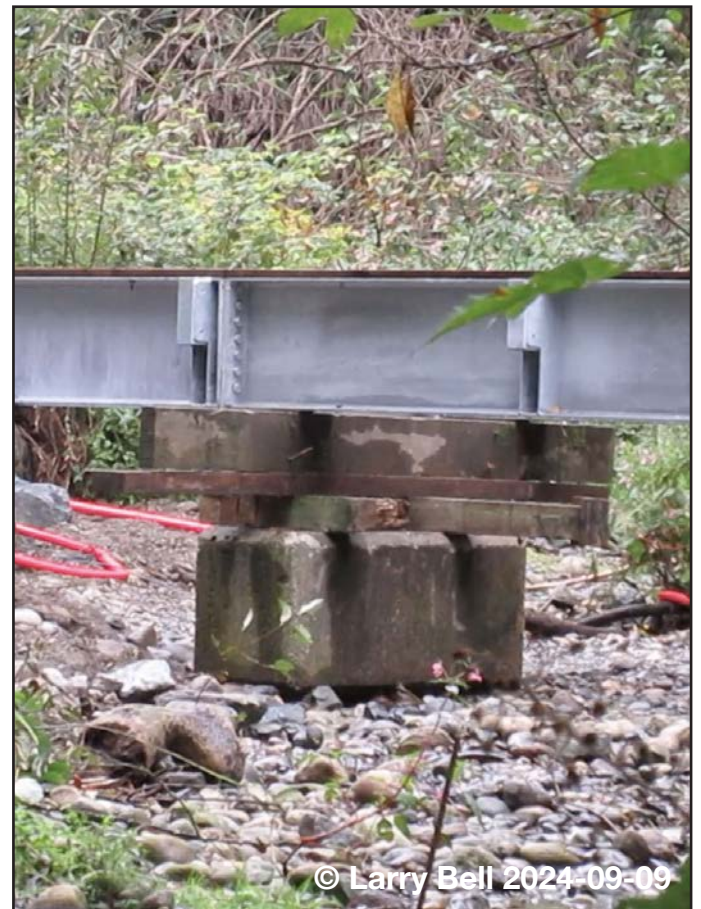
**Above:** the two halves of the Bridge arrived by truck and within hours were in place and bolted together. Notice the Creek bed is dry. **Below:** the public was not allowed in the work area, so our first glimpse of the Bridge was from a distance. Work progressed quickly so the Creek could be restored.

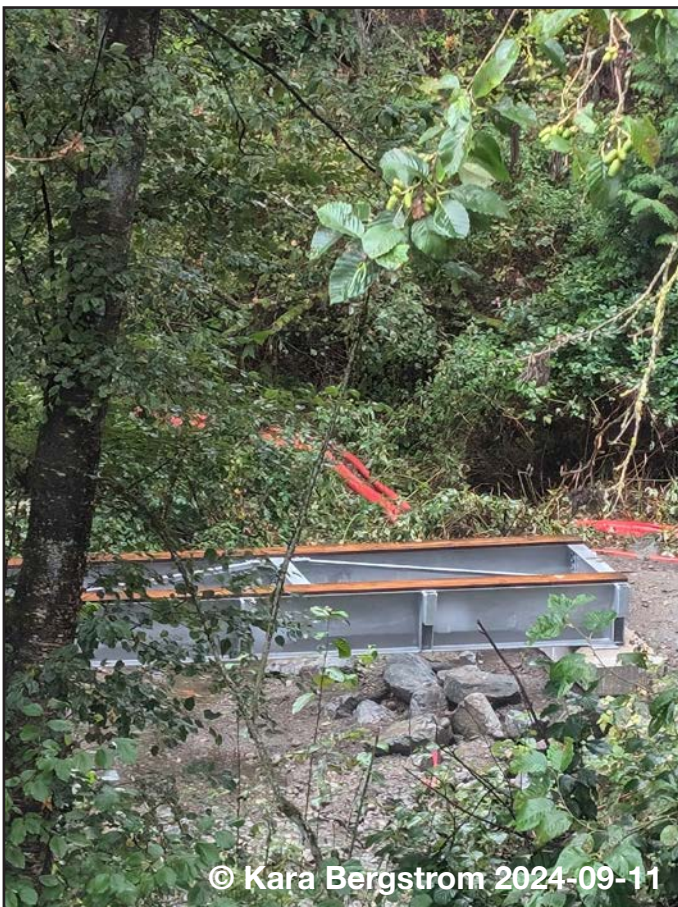
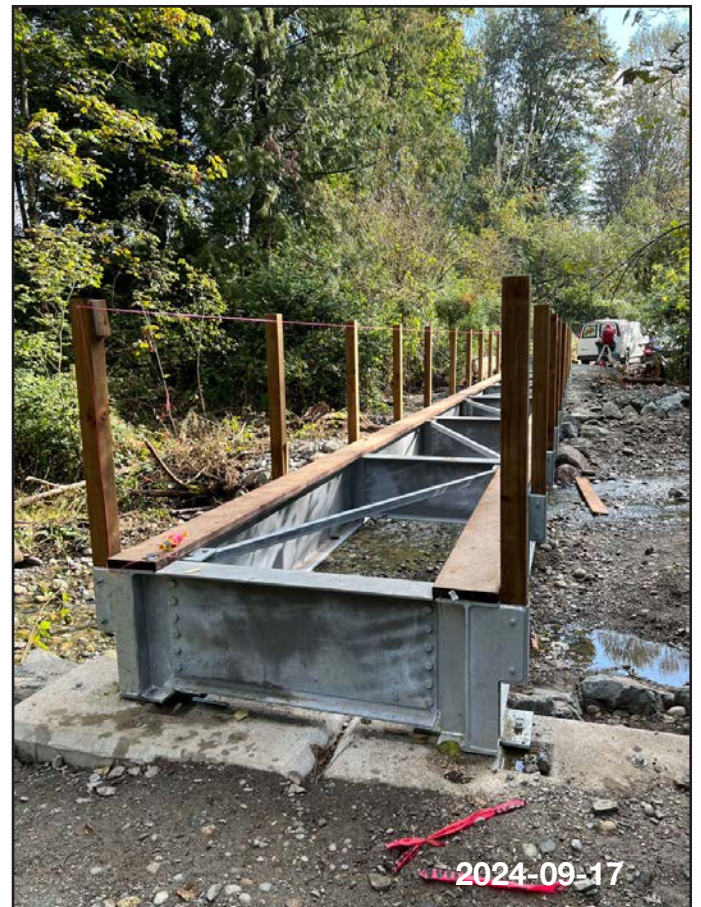
**Above:** the woodwork included a frame to retain a gravel ramp at the north end. **Below:** at the south end, boulders were used instead of a wood frame. While the Bridge was being assembled, machine operators were spreading new gravel and building up the path south of the Bridge.

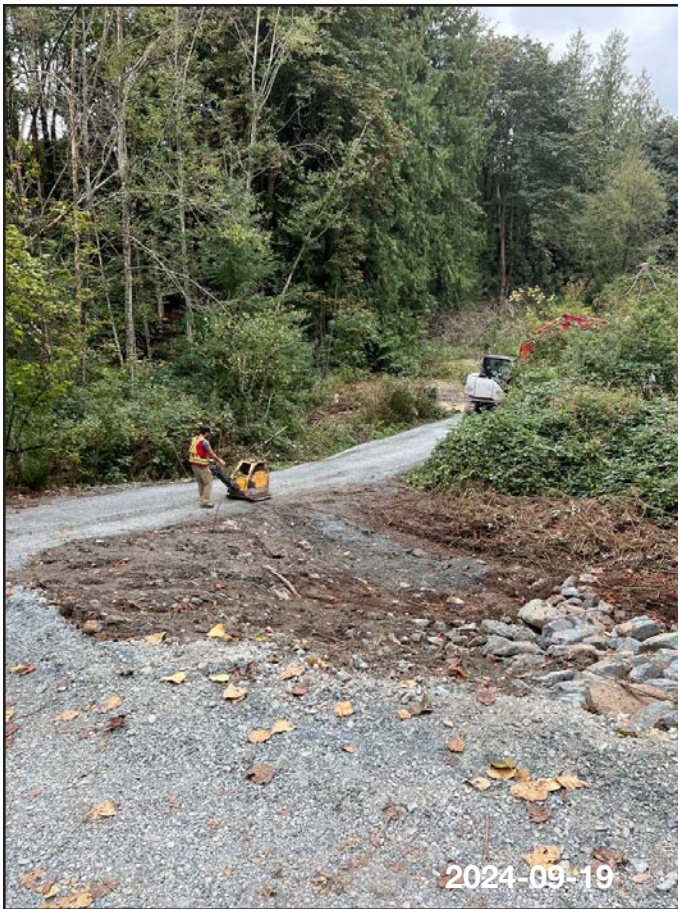
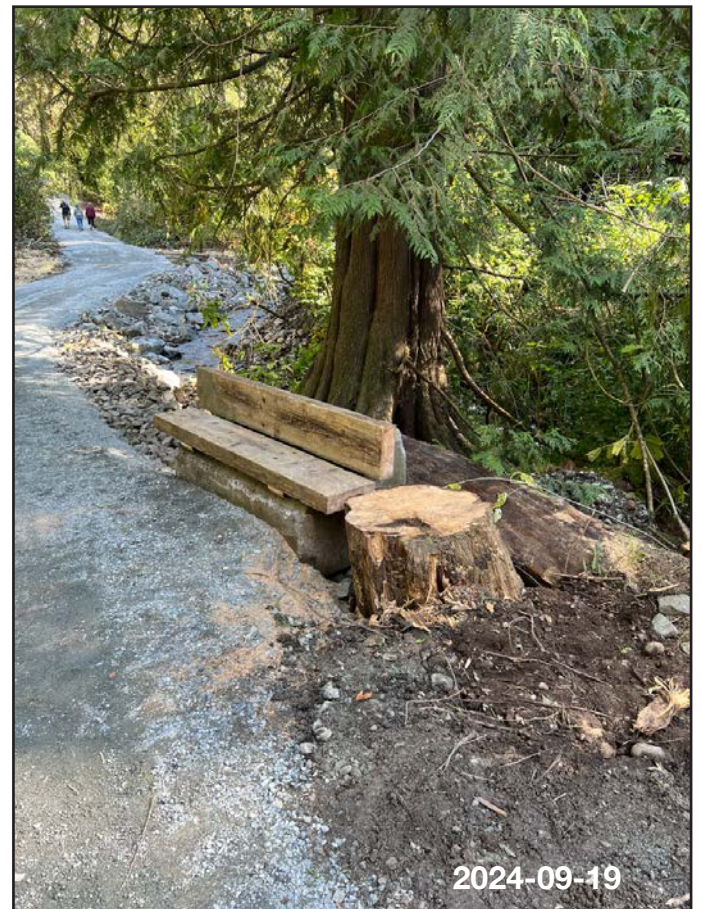
**Above:** tamping the gravel was the finishing touch to the section of Trail below the Forks. That kid-sized bench was a nice idea. **Below:** The project was now finished, and the Bridge easily passed the “wheelchair access” test. The entire Creek is now flowing down that small channel.
